**Loading, Degradation and Repair of
F-111 Bonded Honeycomb Sandwich
Panels - Preliminary Study**

S. Whitehead, M. McDonald and
R.A. Bartholomeusz

DSTO-TR-1041

**Airframes and Engines Division
Aeronautical and Maritime Research Laboratory**

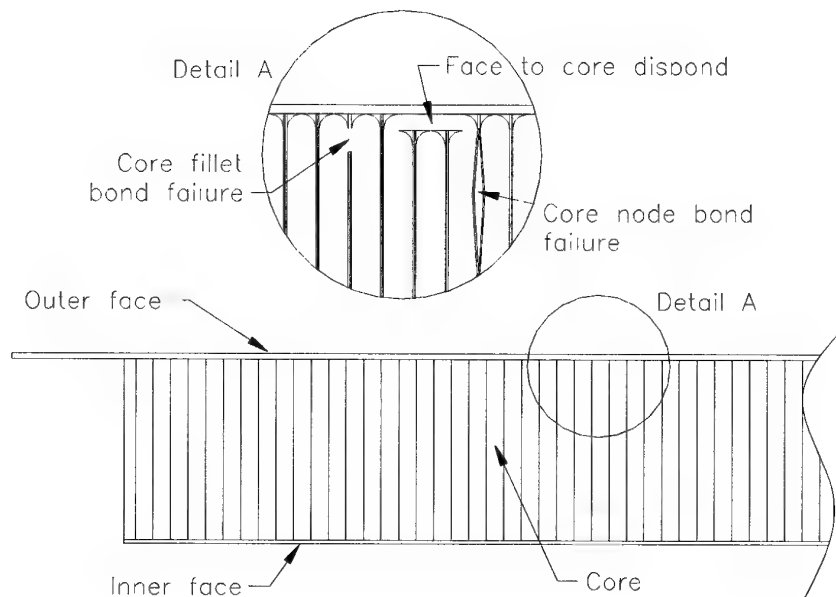
Figure 2: Failure of adhesive bonds in sandwich panels after degradation.

Adhesive bond failure is generally exhibited in three types of failure; face to core disbonding, core fillet bond failure and core node bond failure. These are described in Figure 2 (adapted from Reference 9). Degradation of the bond strength through exposure to moisture and free water will decrease the strength of these bonds. Sandwich panels are generally designed so that the core fails in shear before the face-to-core bond or fillet bond fails. Reduction in bond strength may change the failure mode and cause premature failure of the panel.

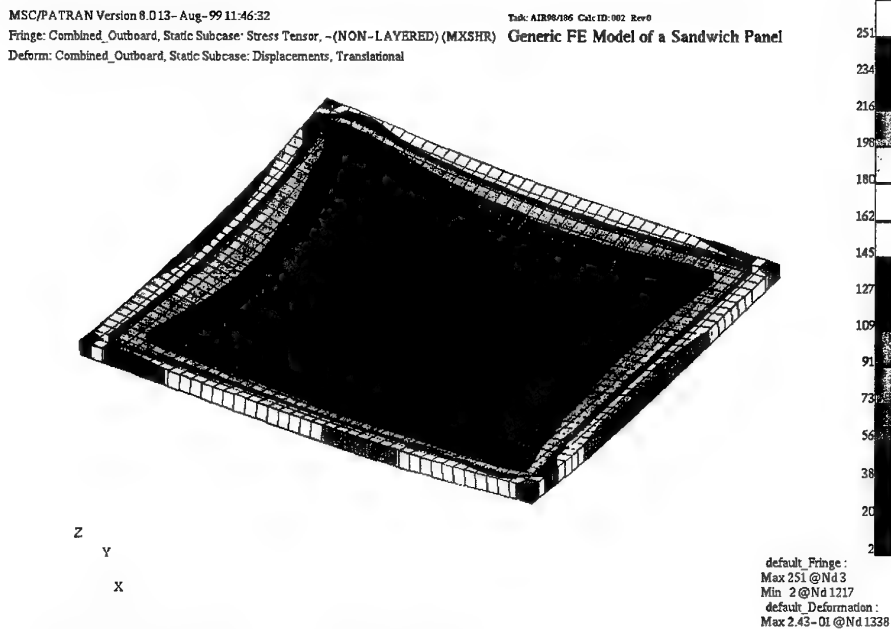
Figure 12: Contour plot of shear stresses in the core

Figure 12 shows a contour plot of the shear stresses in the core. The core shear stresses are representative of the shear loads experienced by the face to core bond. The stresses compare very well with the OEM calculations, despite the coarseness of the simplified FE model. (It is important to note that both the OEM calculation, and the FE analysis reported here, were both similarly simplistic and the true shear stress distribution in panel 3208 may be different.) The results also indicate higher core shear stresses near the panel edges (~250 psi).

Based on the findings of the simplified FE model, the application of the ultimate static load to the panel is sufficient to generate core shear stresses of around 250 psi. At this time no conclusions can be drawn regarding the ability of the panels to withstand the ultimate load in the degraded or damaged condition due to the lack of a knock down factor or allowable for panel degradation in sandwich-panels. Work is required to develop these knockdown factors.

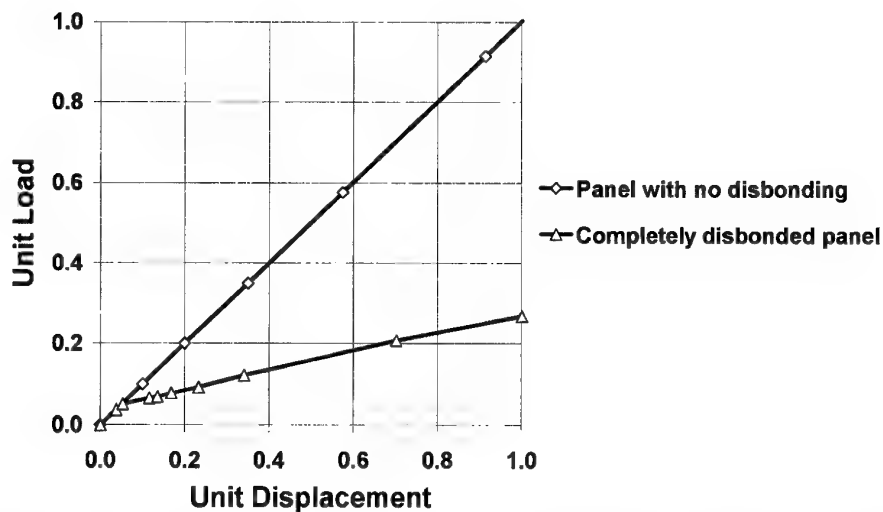
Figure 14: Load-displacement response of an intact panel and a completely disbanded panel.

The load-displacement response is shown in Figure 14 and this shows that the onset of general buckling instability begins at about 5% of ultimate load. Further, more realistic, work is planned which will consider the effect of smaller disbonded regions.

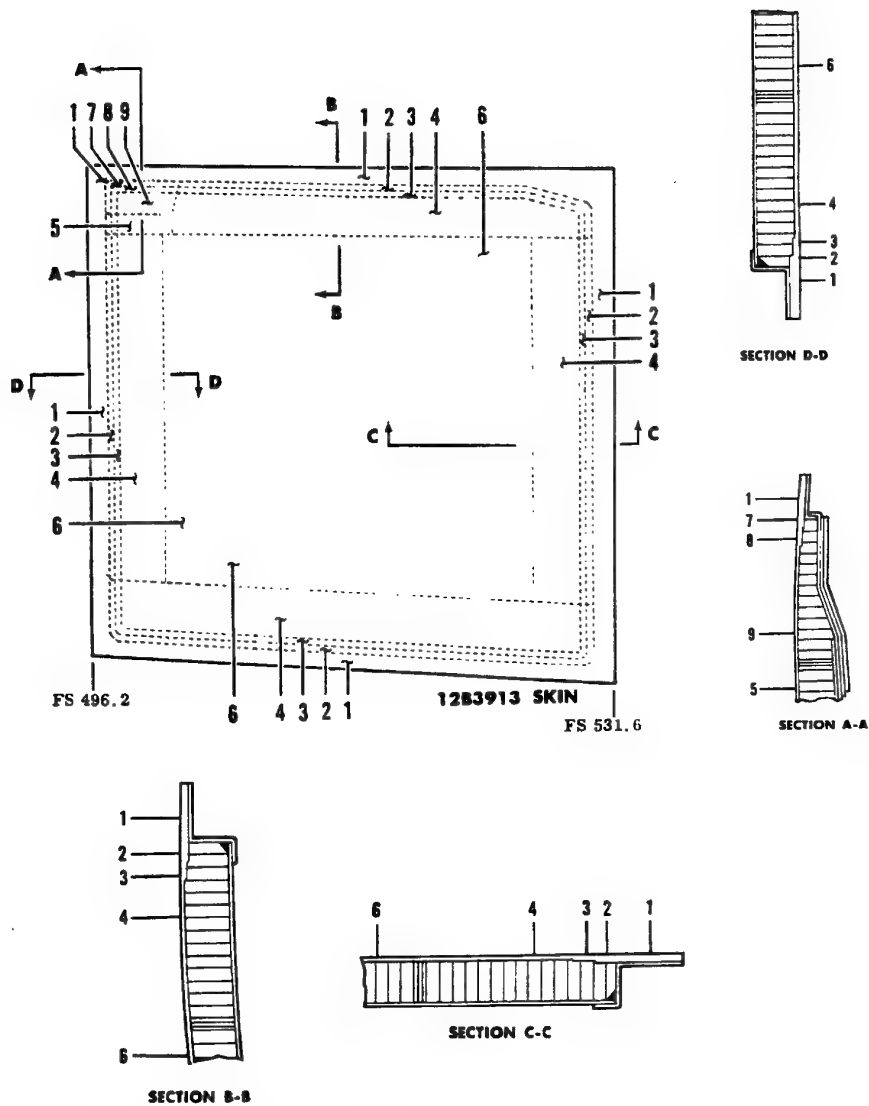
Figure 16: Structural detail of panel 3208. [2]

An initial list of 14 defect report summaries were provided. Of these, five reports were deemed relevant and had further details available. Appendix B contains the numbers of the reports considered. Some reports relate to panel 3108, the panel with the same part number, but on the opposite side of the aircraft.

Table 2 is a description of the defects that have occurred in panel 3208 along with pictorial representations of the defects. (Note that these diagrams are not intended to be an exact replication of the defect, rather an approximate representation of their size and shape.)

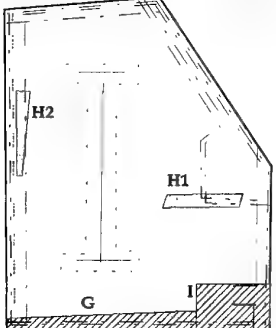
F	Face disbonded	-	
G	Extensive corrosion on face	Ingress of moisture through door seal

H	Face-to-core disbond, problem exacerbated during repair attempt	Moisture in panel; moisture caused further disbond during cure cycle of repair	
I	Face to core disbond	-
